No. **96-1**

SUBJECT: Fuel Tank Cap

Date: December 18, 1995 SUBJECT: Heat Shields

SUBJECT : Brake System

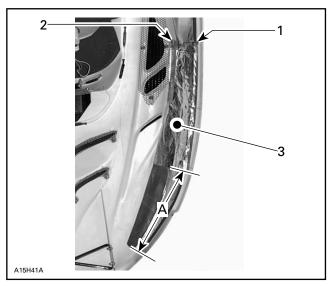
INNER RIGHT SIDE OF HOOD

Should the hood louvers become blocked with snow the acoustic foam on inner right side of hood and surface on bottom pan in front of muffler may melt and cause damage.

- 1. Overlap 12mm (1/2 in)
- 2. Flush with side of grill
- 3. Heat shield decal
- A. 330 mm (13 in)

The decal should overlap the foam surface by approximately 12 mm (1/2 in) on the inner side of the hood.

Measure 330 mm (13 in) from the front edge of the existing acoustic foam.

Remove backing paper from decal then apply to cleaned surface.

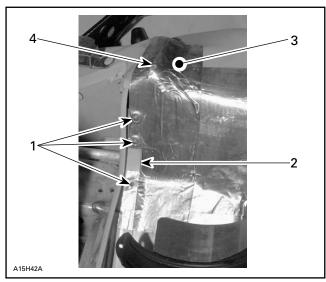
- Center holes with rivets
- 2. Notch
- Apply this side first
- 4. Slit (apply this side last)

Apply the lower portion of the decal first, paying attention to center the pre-cut holes with the rivets in the bottom pan.

Apply the slit portion last to overlap other side of decal.

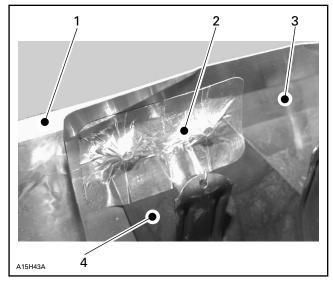
- Bottom pan Heat shield decal
- Heat deflector
- Muffler support

Remove backing paper from decal, center the decal over the self-tapping screws then apply to cleaned surface.

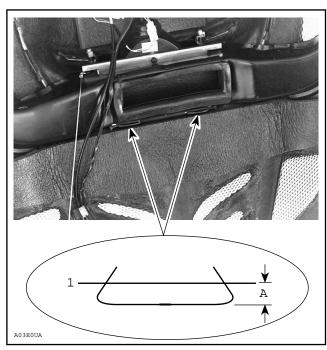
Tabs for headlight trim may interfere with spark plug boots.

1. Cut here A. 6 mm (1/4 in)

Mark and cut 6 mm (1/4 in) off of the two center tabs. Remove any sharp corners by rounding off the edges. Refer to the following illustration.

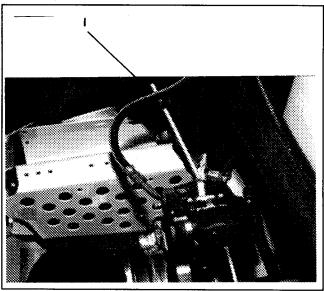
1. Route brake hose away from rewind starter cord

WARNING: Pay close attention when routing the brake hose upward. Avoid contact with the rewind starter cord.

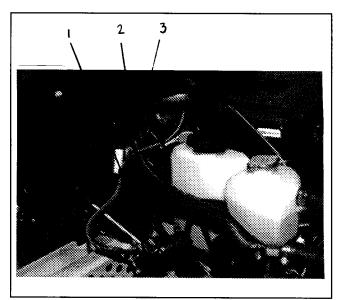
- 1. Locking tie to vertical frame tube
- 2. Locking tie to wiring harness upper column slot
- 3. Locking tie to secure wiring harness to main wiring harness.

First, secure brake hose to vertical frame tube then secure to existing wiring harnesses. Refer to photo on next page.

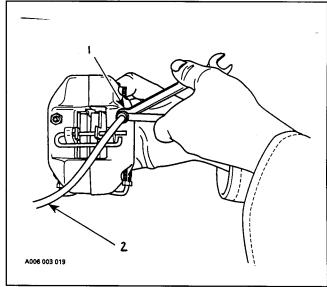
- 1. Hold bleeder adaptor while opening bleeder
- 2. Clear hose to catch used brake fluid

Pump brake lever a few times and while holding brake lever depressed, open bleeder and check for air to escape.
