**SNOWMOBILES**

No. **98-1**

**SUBJECT: Fixed Half Splines**

**SUBJECT: Fuel Line Replacement**

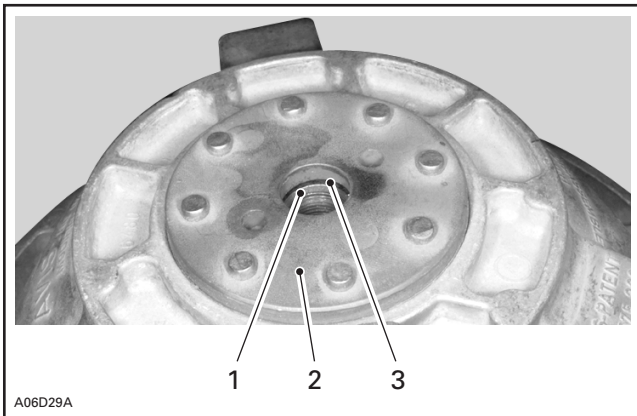
On some units, inner shaft splines may not have been machined deep enough (length wise) creating a gap between governor cup damper and inner shaft end; this may cause clutch fragmentation at high speeds.

- A visual inspection will tell if a gap is existing. Refer to following illustration.

- Inner shaft
- Governor cup
- Check gap here

- If **gap is existing**, replace inner half and verify pulley alignment.
- On vehicle equipped with an electric starter, removal and reinstallation of ring gear will be required.

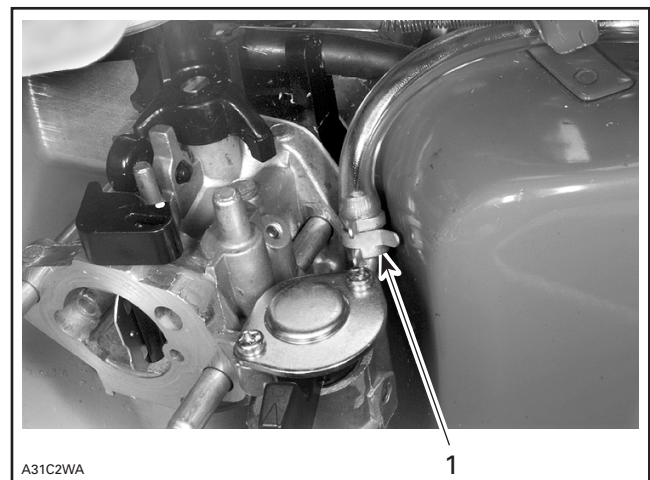
Ensure fuel line does not overlap on 90° fitting elbow.

1. Spring clip correctly installed

Replace fuel line, spring clips and locking tie with new ones.

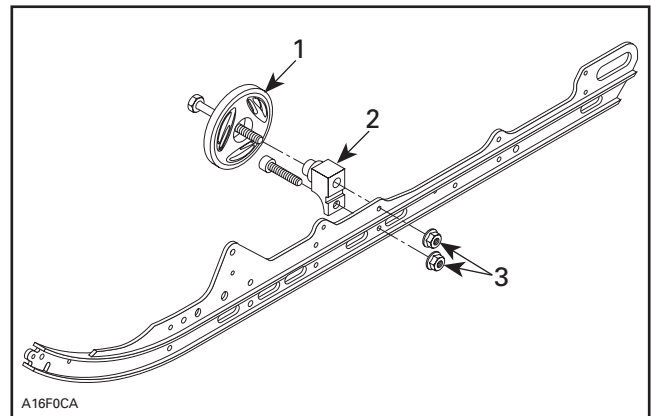
When suspension is compressed under normal riding conditions, the center support wheels may come in contact with upper track support wheels.

**CORRECT POSITION OF SUPPORT WHEEL**

Remove support from rail and reinstall in the next hole to the rear on the rail.

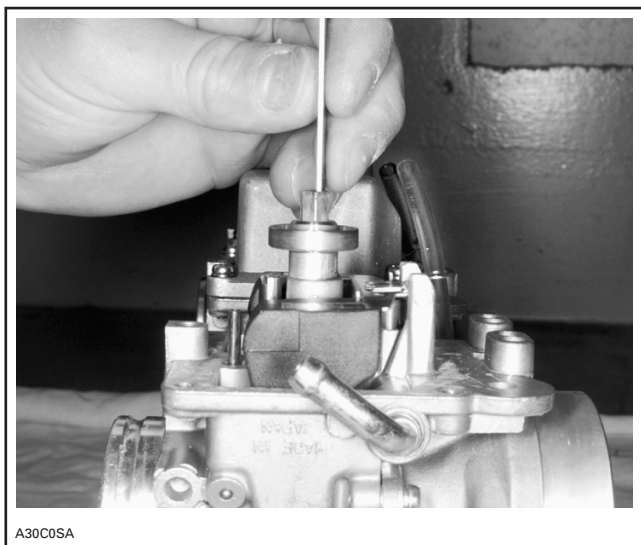
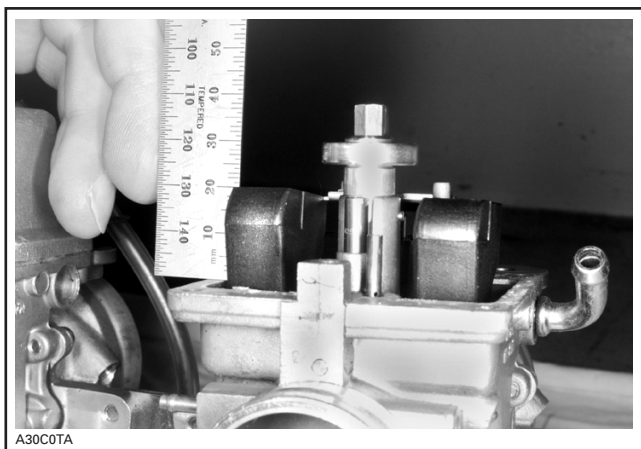
RULER IN LINE WITH MAIN JET HOLE

ADJUST FLOAT HEIGHT TO NEW SPECS.

- a. With carburetor upside down on a level surface and a ruler in line with main jet hole, adjust float level at 21 mm (+0, -1) (0.827 in (+0, -0.039)). Refer to following photos.

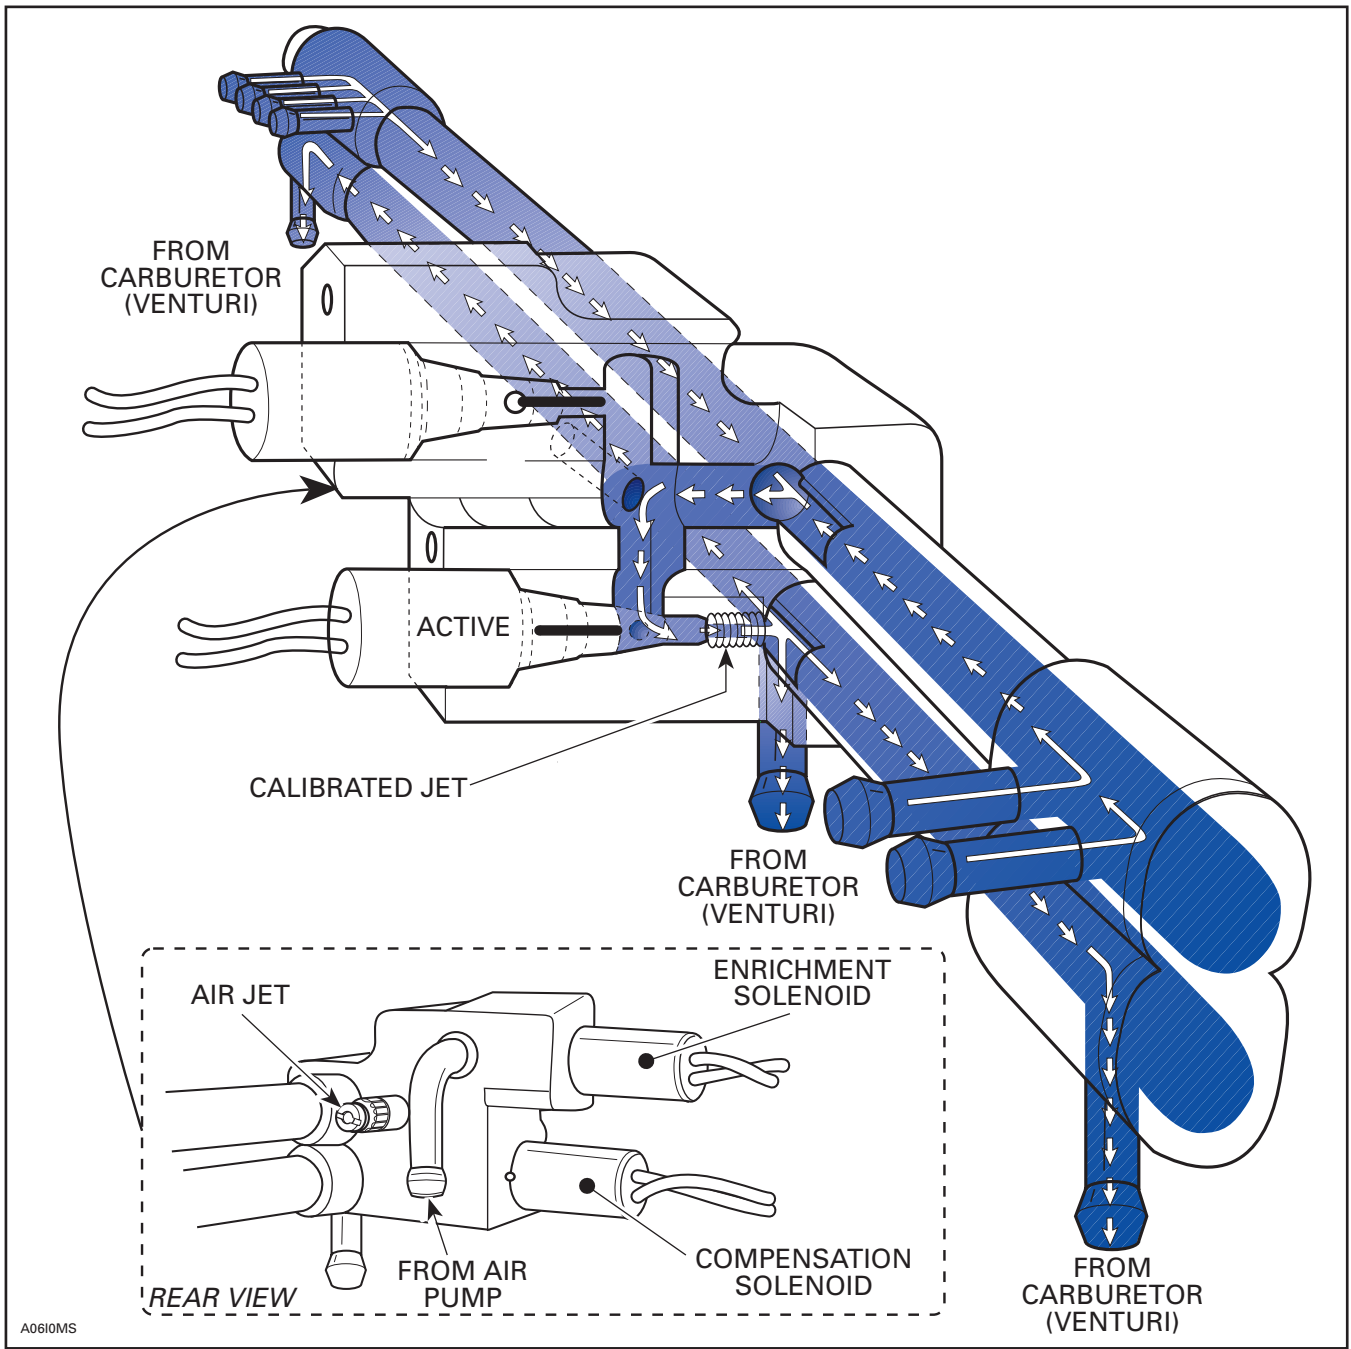
Some of the above mentioned snowmobiles might experience a rich fuel mixture over 7000 RPM; this would be caused by a loose air jet in distribution gallery block adaptor.

Secure distribution gallery to air intake.

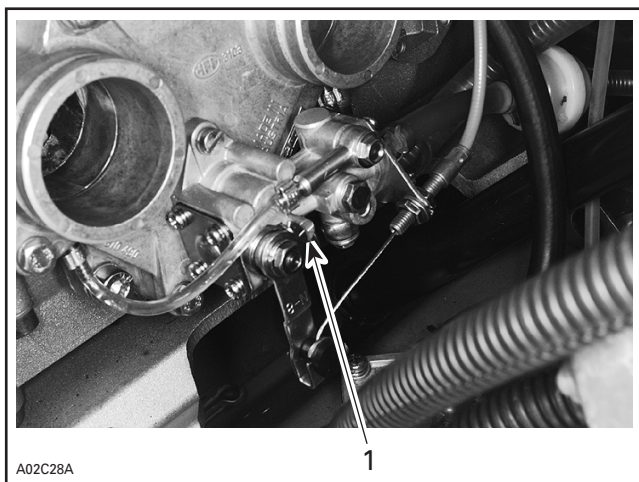
Under certain operating conditions, a too lean calibration may cause piston seizure and/or PTO bearing failure.

1. Alignment marks under new specification

Loosen adjuster nut and set marks according to above mentioned tolerance. Refer to following photo.
