No. **98-2**

**REVISION 1** ←

Date: October 28, 1997

**SUBJECT: Fixed Half Splines**

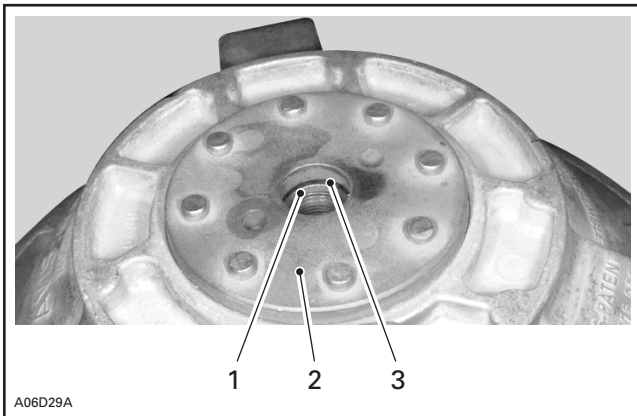
On some units, inner shaft splines may not have been machined deep enough (length wise) creating a gap between governor cup damper and inner shaft end; this may cause clutch fragmentation at high speeds.

- a. A visual inspection will tell if a gap is existing. Refer to following illustration.

1. Inner shaft
2. Governor cup
3. Check gap here

- b. If **gap is existing**, replace inner half and verify pulley alignment.
- c. On vehicle equipped with an electric starter, removal and reinstallation of ring gear will be required.

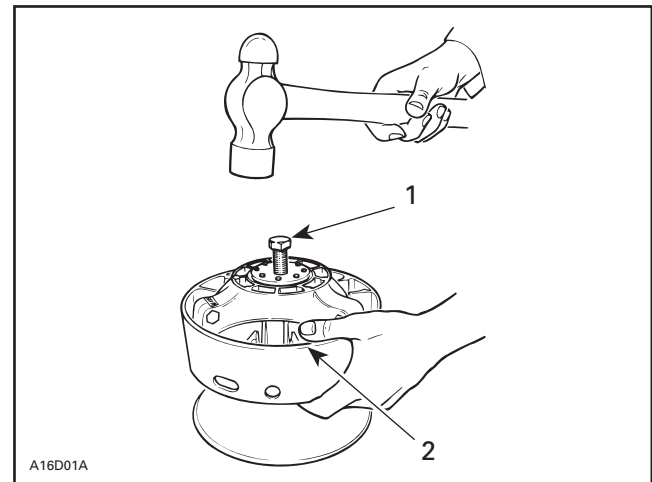
TYPICAL

1. Puller
2. Holding sliding half

Screw puller into fixed half shaft about 13 mm (1/2 in). Raise drive pulley and hold it by the sliding half while knocking on puller head **using a rubber mallet** to disengage fixed half.
