**SNOWMOBILES**

No. **98-1**

**SUBJECT: Fixed Half Splines**

**SUBJECT: Fuel Line Replacement**

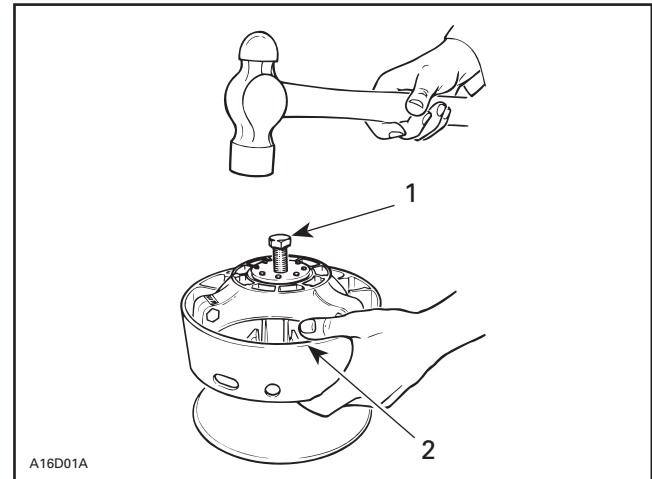
- Puller
- Holding sliding half

Screw puller into fixed half shaft about 13 mm (1/2 in). Raise drive pulley and hold it by the sliding half while knocking on puller head **using a rubber mallet** to disengage fixed half.

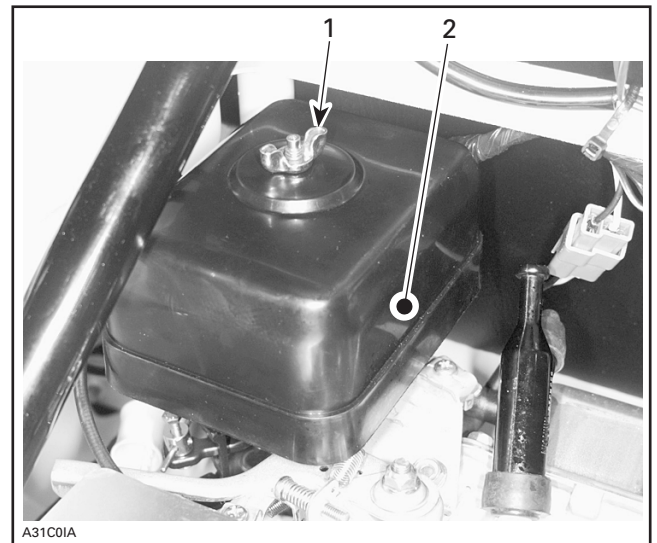
1. Loosen wing nut
2. Remove air intake cover

Loosen wing nut and remove air intake cover, as shown in the next photo.

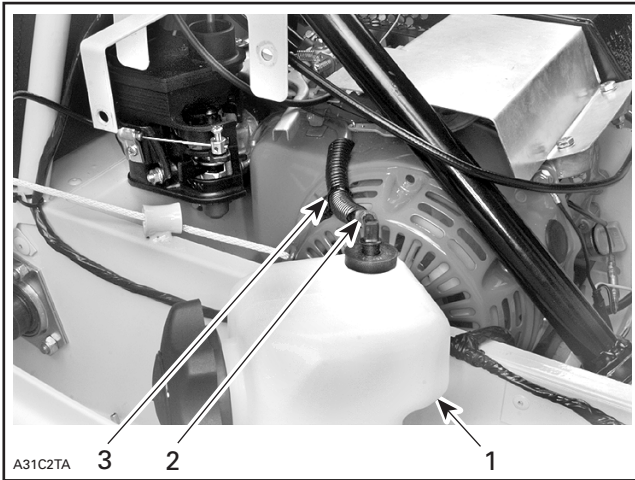
1. Fuel tank
2. Disconnect fuel line
3. Cut locking tie

Detach line from fuel tank.

Cut locking tie retaining fuel line to starter housing

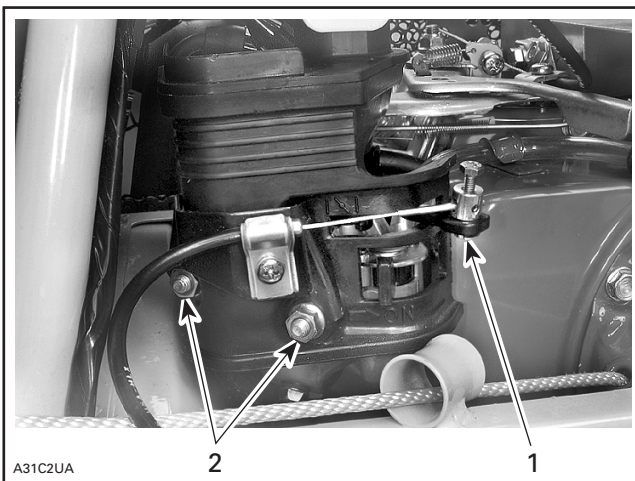
1. Remove clip
2. Nuts retaining bracket

Remove clip and detach choke cable attachment from choke lever.

Remove 2 nuts retaining choke cable bracket to carburetor.

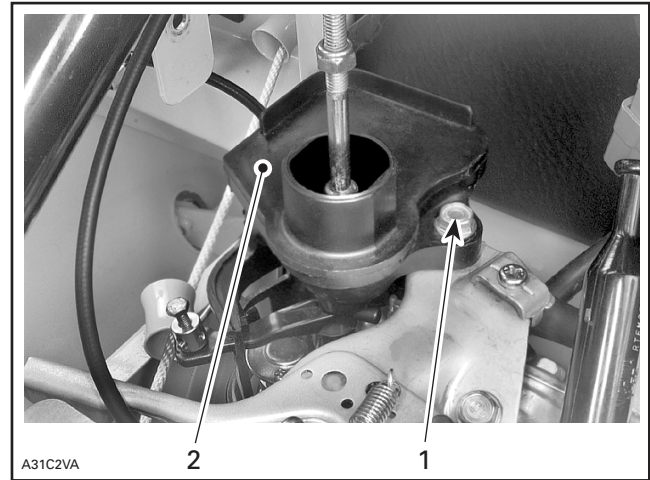
1. Remove screw
2. Air intake

Remove screw retaining air intake to engine housing and remove air intake.

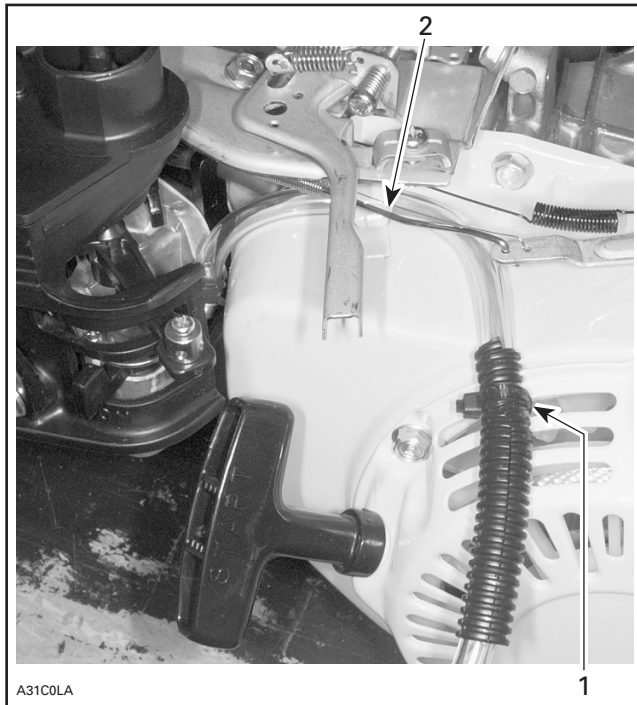
1. Locking tie
2. Engine cover clip

Route new fuel line into engine cover clip.  
 Insert original protector onto new fuel line and secure line with locking tie.

**NOTE:** Ensure that protector is properly positioned, as shown in the next photo.

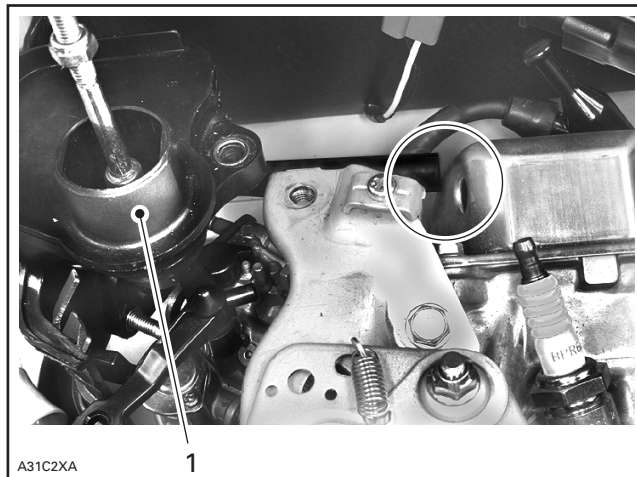
1. Air intake

Reinstall air intake.

**NOTE:** When reinstalling air intake, make sure to route breather hose into hole provided in valve cover.

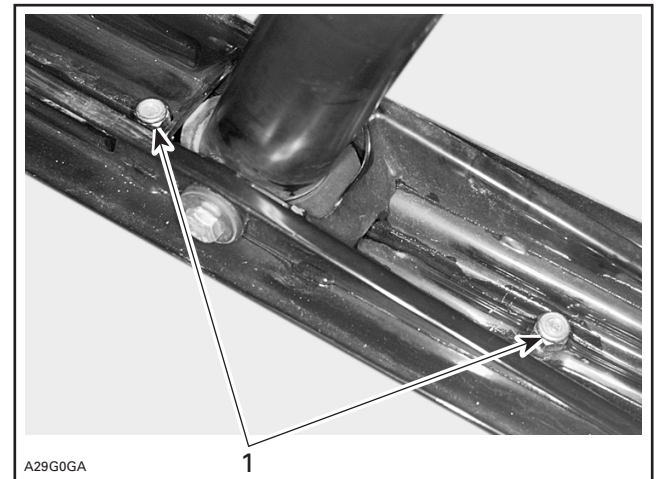
1. Remove nuts and discard

Remove the two M10 elastic stop nuts retaining ski runner and detach ski runner from ski.

Discard M10 nuts.

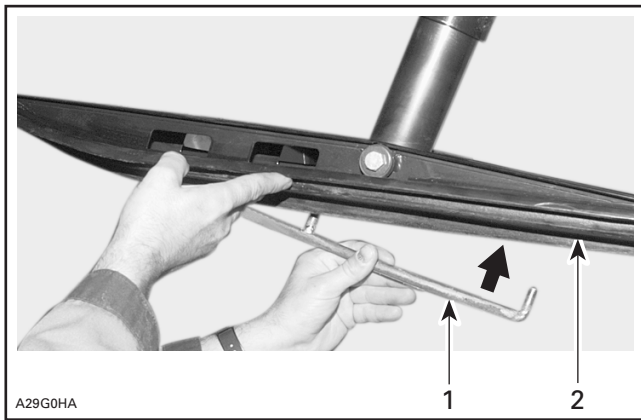
1. Reinstall ski runner
2. Plastic ski liner

Position ski liner under the ski.

Insert front end of ski runner first then install ski runner on the ski.

Secure with new M10 elastic stop nuts.

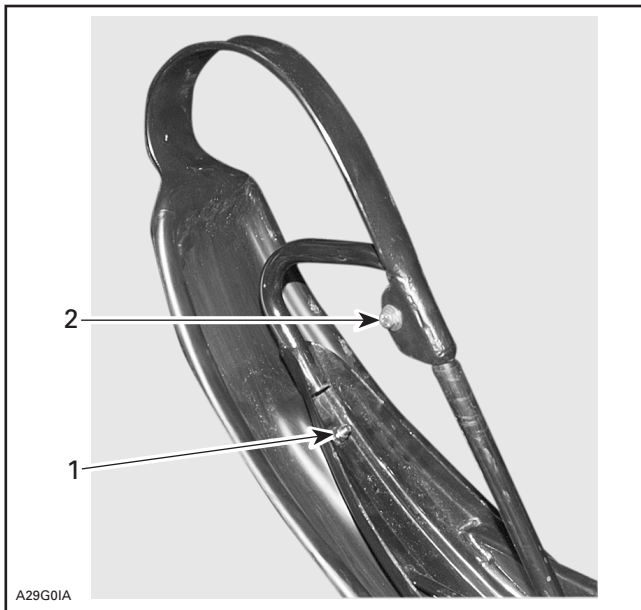
1. Carriage bolt and flanged nut
2. M6 bolt, flat washer and nut

Attach front end of ski liner to the ski and secure with carriage bolts and flanged elastic stop nuts included in the kit.

Attach plastic strap of ski liner to the ski handle and secure with M6 bolts, flat washers and elastic stop nuts M6.

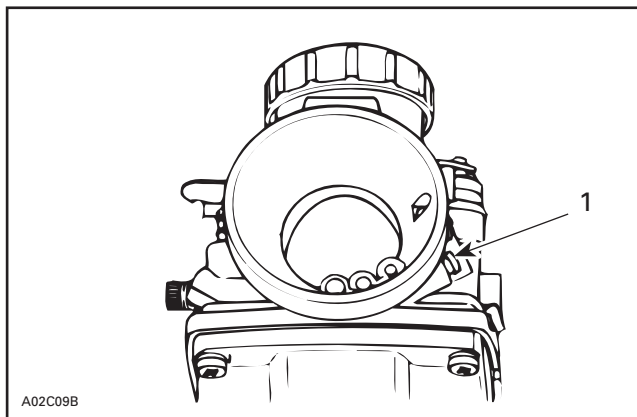
VIEW FROM AIR SILENCER SIDE

1. Air screw

Loosen rubber flange clamp on both carburetor and rotate carburetors counterclockwise to facilitate air screw adjustment.

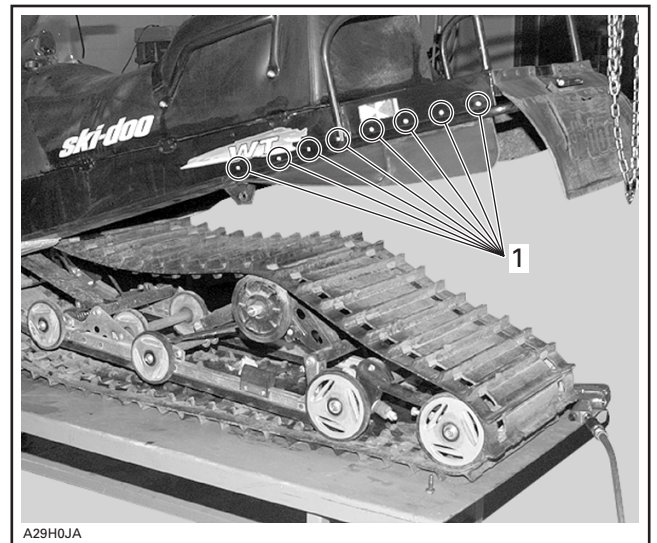
1. Rivets

Apply tape on the outside of the tunnel and over the heads of the rivets to protect the paint.

From the outside hold a metal stopper against the rivets.

With a hammer, tap on the rivets inside the tunnel, both sides, to flatten the exceeding part.

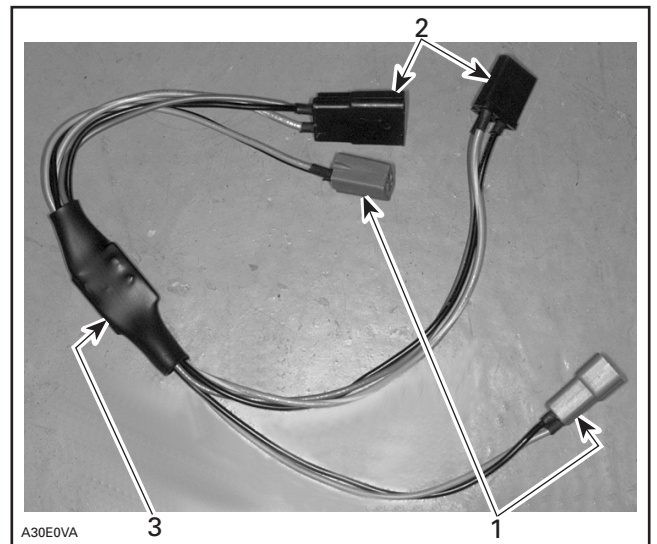
**ELECTRIC FILTER HARNESS**

A fluctuation of the electric current, when engine is started, is the cause.

- 1. GRAY connector housings
- 2. BROWN connector housings
- 3. Integrated filter

Refer to following photo.

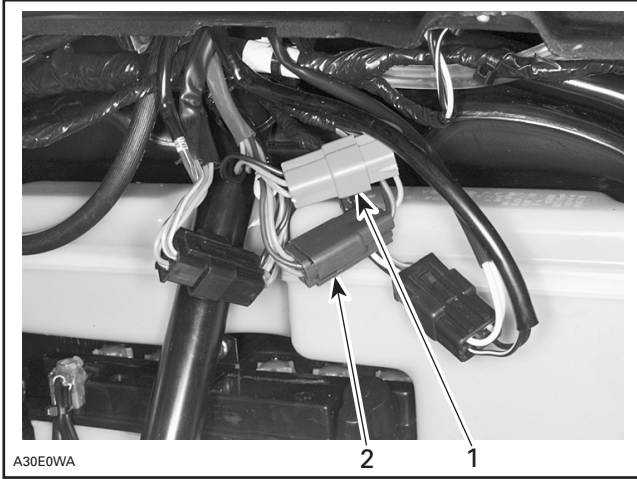
### MAIN WIRING HARNESS

1. GRAY connector housings
2. BROWN connector housings

Unplug BROWN and GRAY connector housings, refer to following photo.

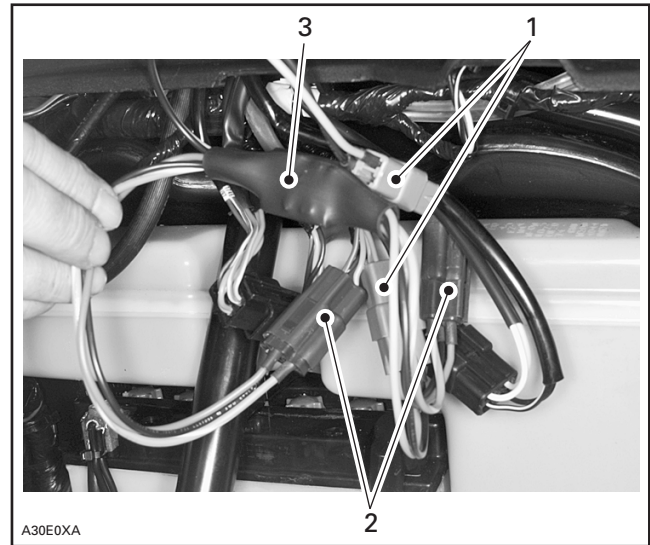
### FILTER CONNECTED

1. GRAY connector housings
2. BROWN connector housings
3. Integrated filter

Secure filter harness with a locking tie.

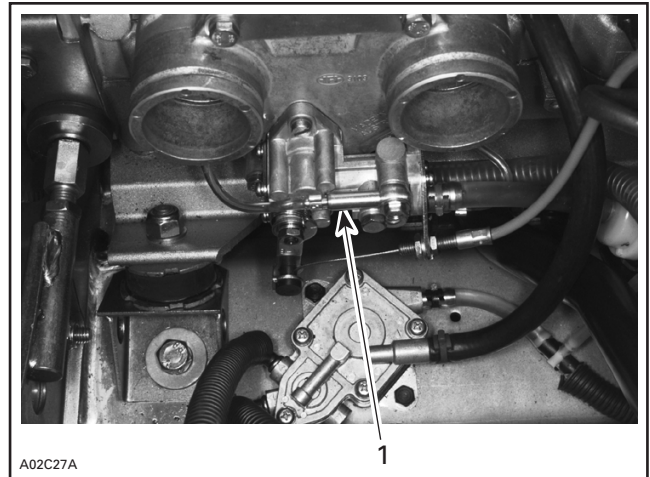
**CARBURETORS REMOVED**

Under certain operating conditions, a too lean calibration may cause piston seizure and/or PTO bearing failure.

1. Oil pump

Loosen both clamps retaining carburetors to rotary valve cover adapters.

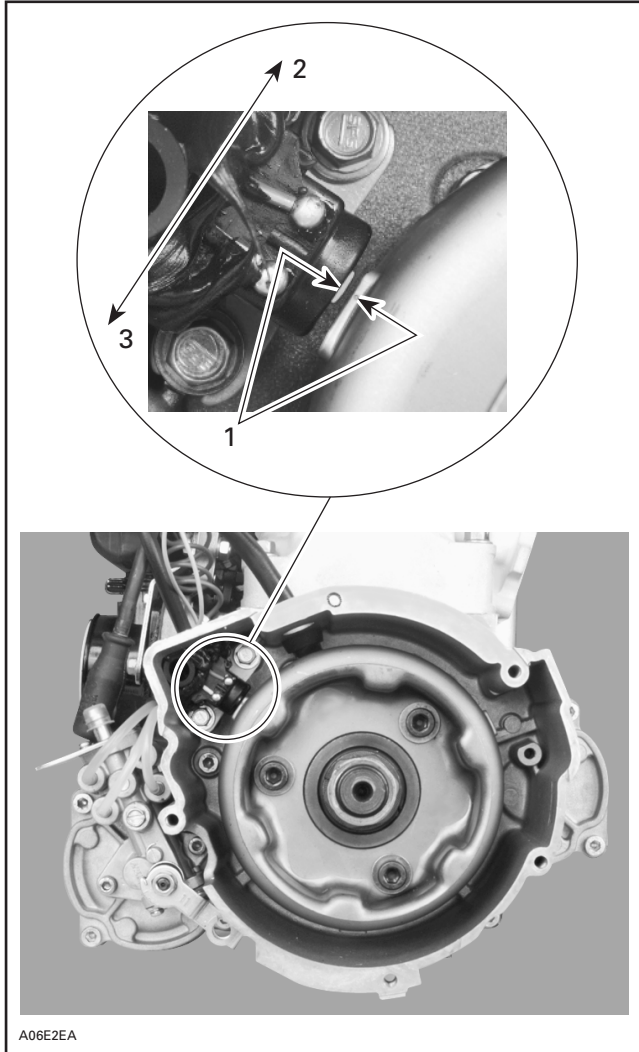
Severe engine damage may occur if ignition timing is not retarded as specified when modifications to carburetor adjustments are performed.

1. Dot aligned with center of trigger coil core
2. Retard
3. Advance

**NOTE:** In some cases, it may be necessary to slot the holes on the trigger coil bracket and replace the upper bolt with by a M5 x 20 Allen head screw (P/N 420 941 540).

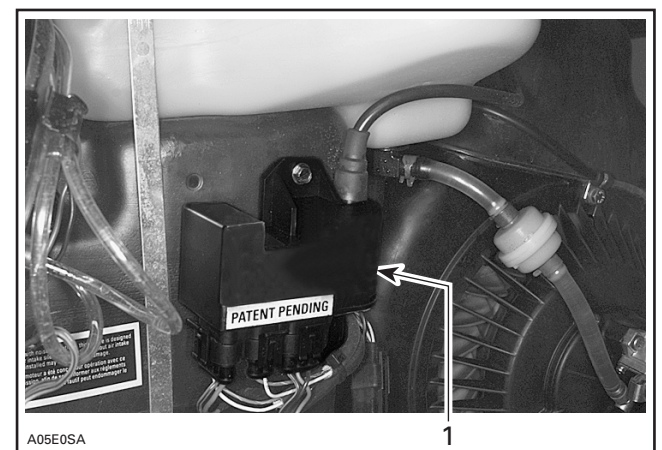
1. MPEM module

Following photo shows positioning of MPEM module.
